Manhole Inspection Summary

Manhole # S65G__017MH

Insp Date: **3/17/08 2:23 PM**

Location Address: **440 Bonsal St.**

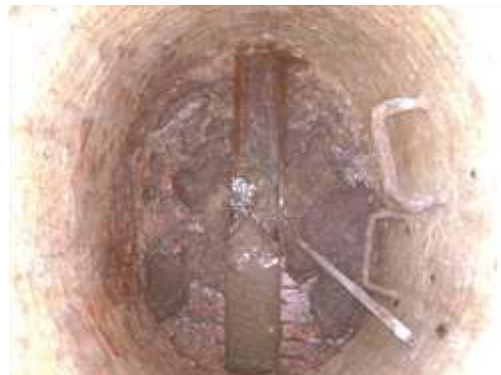
Top View

Comments **MANHOLE IS IN BAD SHAPE WITH A SERIOUS DEFECT IN THE BARREL ABOVE THE OUTGOING 12 O'CLOCK. MORTAR IS MISSING AND A VOID IS VISIBLE.**

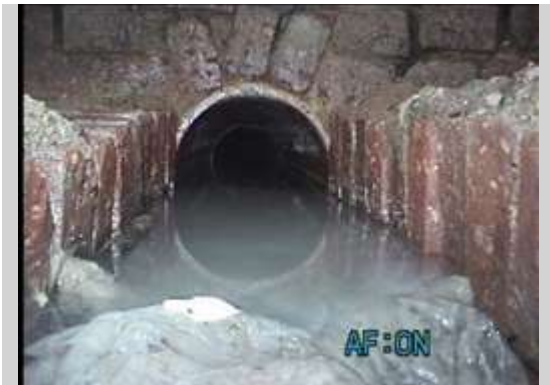
6 O'Clock Inflow

8 in. Circular Gravity Sewer
Pipe In @ 6 O'Clock

Infiltration: **None** Pipe Seal Cond: **Sound**
